1. Project Name: Kahului DDH
2. Date of Inspection: May 13, 2005
3. Inspection Personnel:

O & M INSPECTION REPORT FOR NAVIGATION PROJECTS

Honolulu Engineer District

KAHULUI HARBOR, MAUI, HAWAII

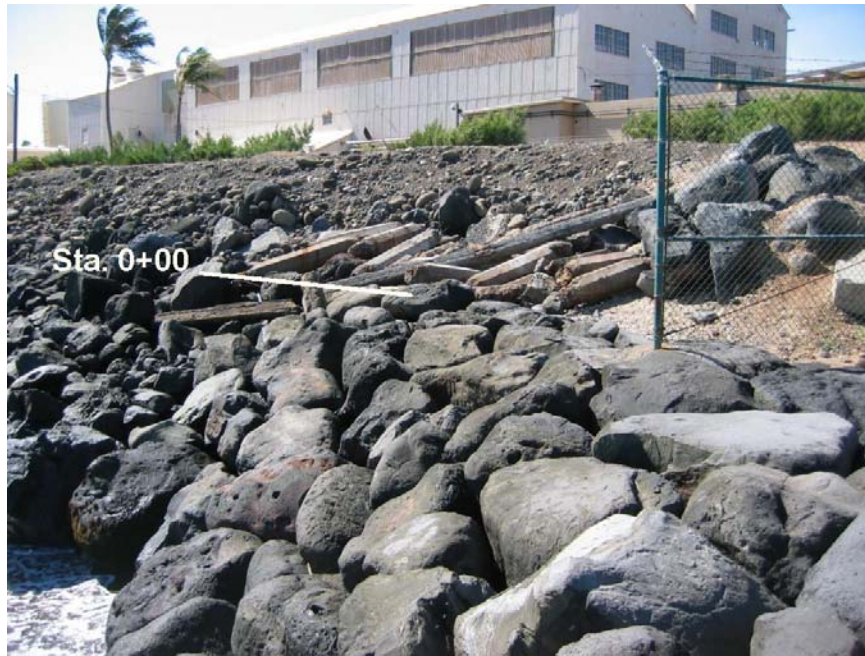
a. Newly established Station 0+00.

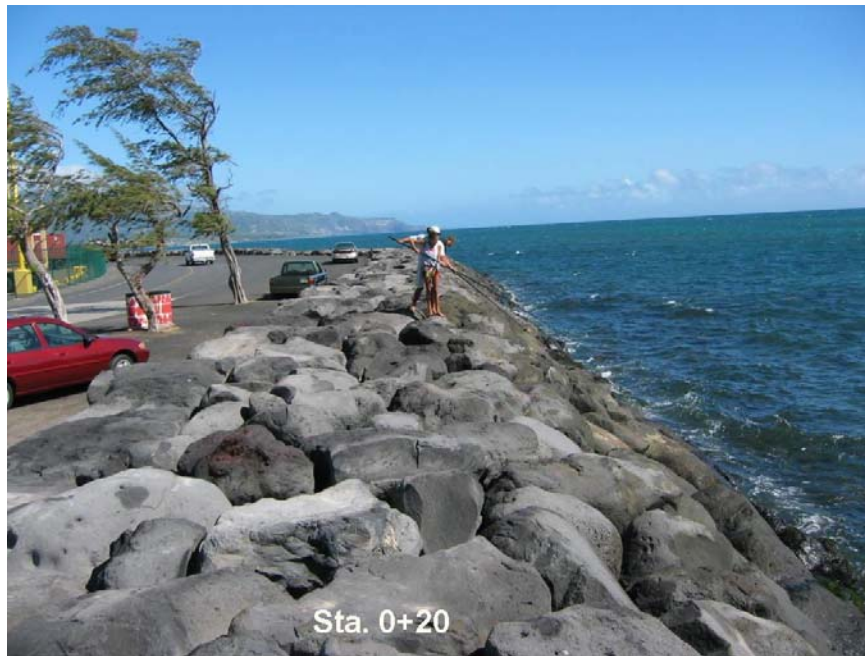
b. Sta. 0+20, Overview, no deficiencies noted.

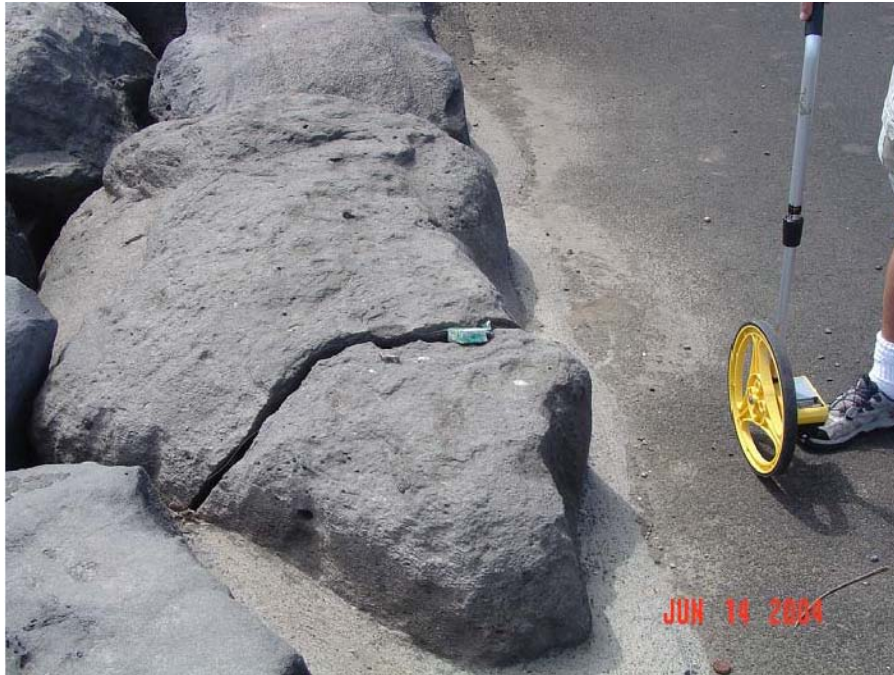
c. Sta 3+08, HS, Cracked armor stone.

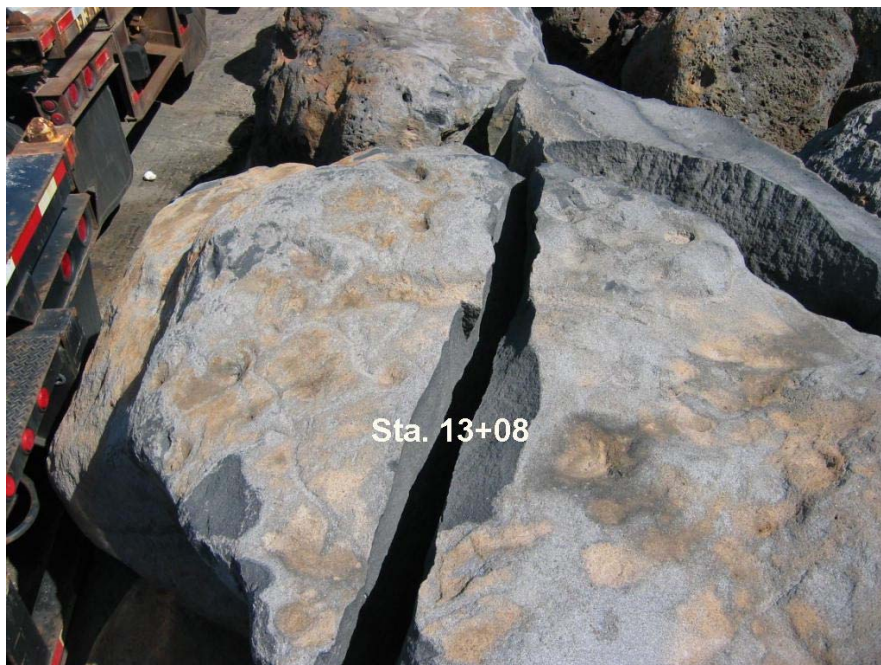
j. Sta 13+08, HS, Cracked armor stone.

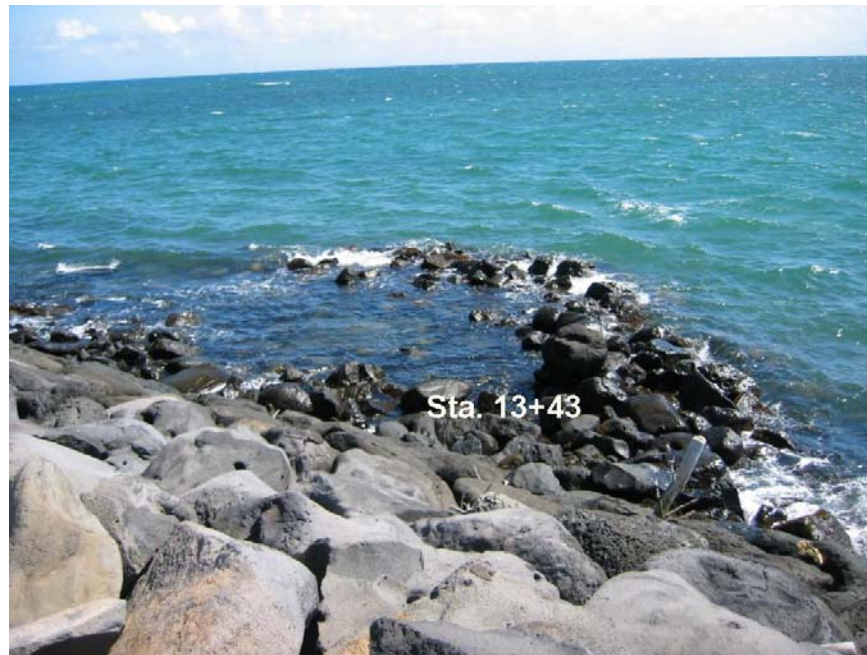
k. Sta 13+43, OS, adjacent stones not from structure.

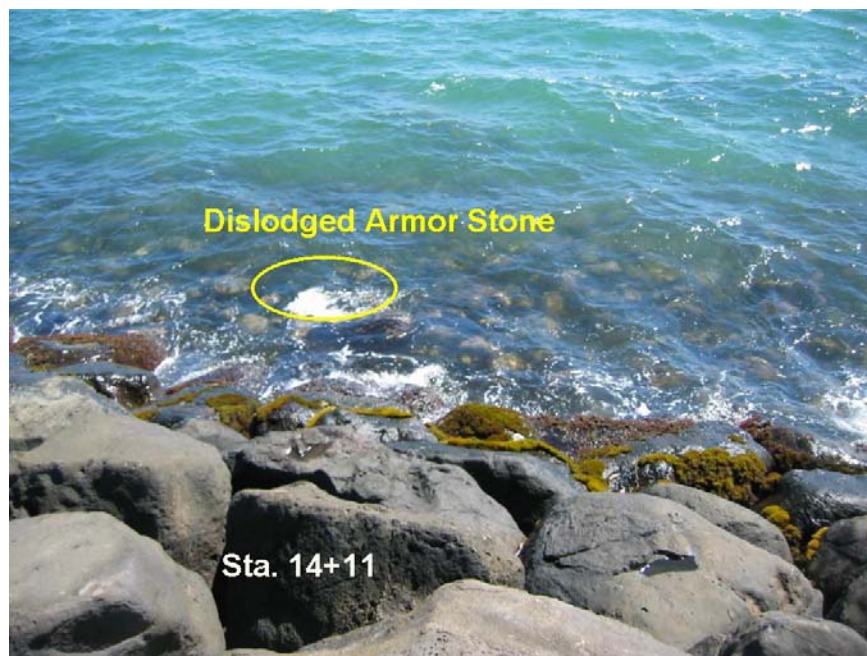
l. Sta. 14+11, OS, Dislodged armor stone at toe.

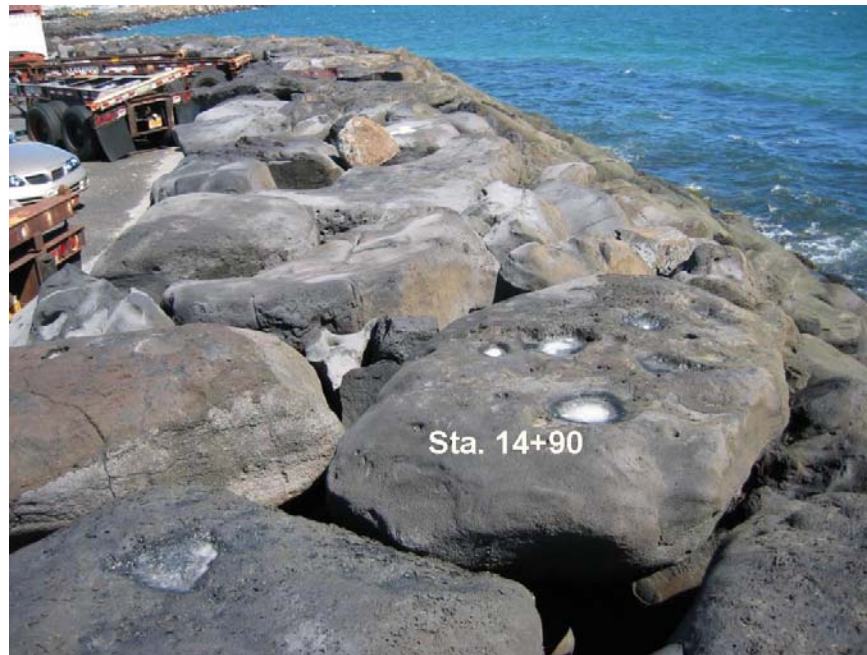
m. Sta 14+90, Bridging of armor stone at crest

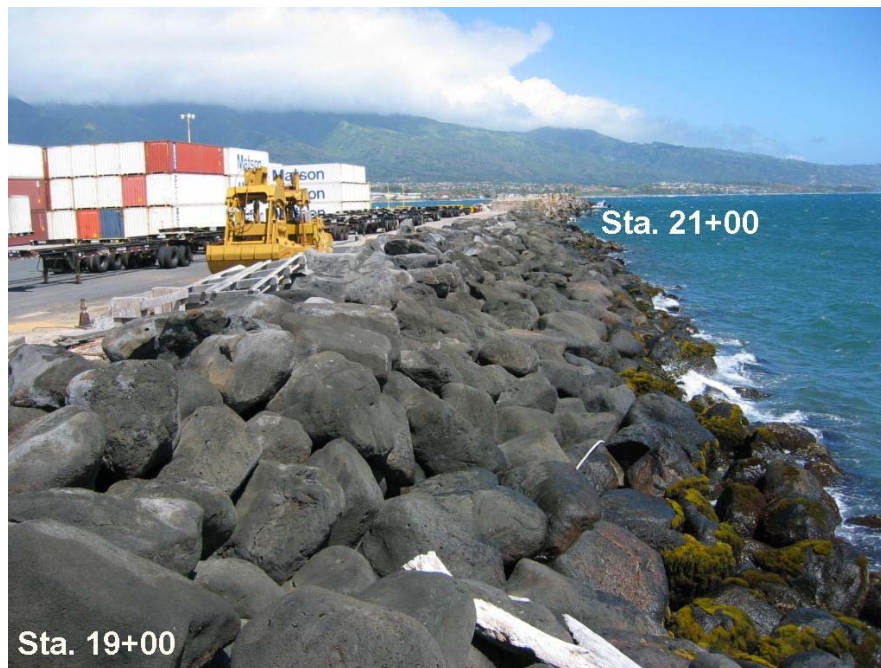
q. Sta 19+00 to 21+00 (end of wall), OS, Monitor sideslope flattening in this area.

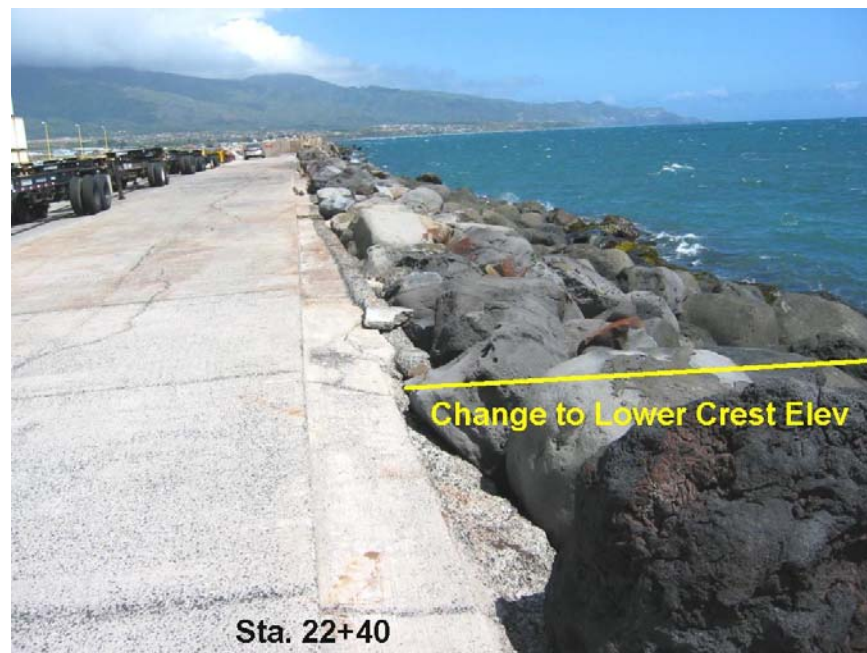
r. Sta 22+40, OS, Crest elevation drops due to repair beginning/end, monitor sideslope flattening.

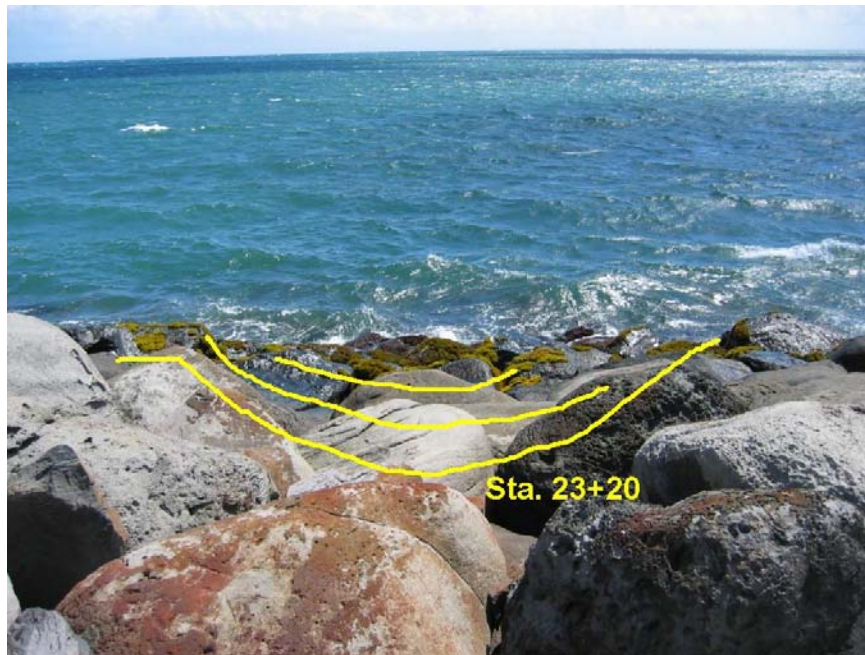
s. Sta 23+20, OS, Slight settling, monitor.

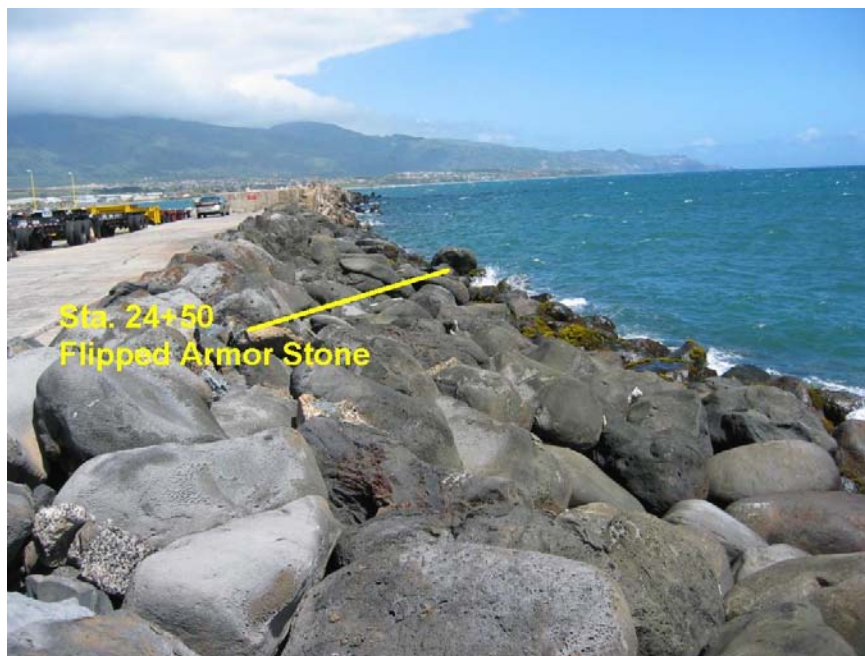
t. Sta 23+20 to 24+67, settling of entire section, monitor.
Flipped armor stone at Sta 24+50

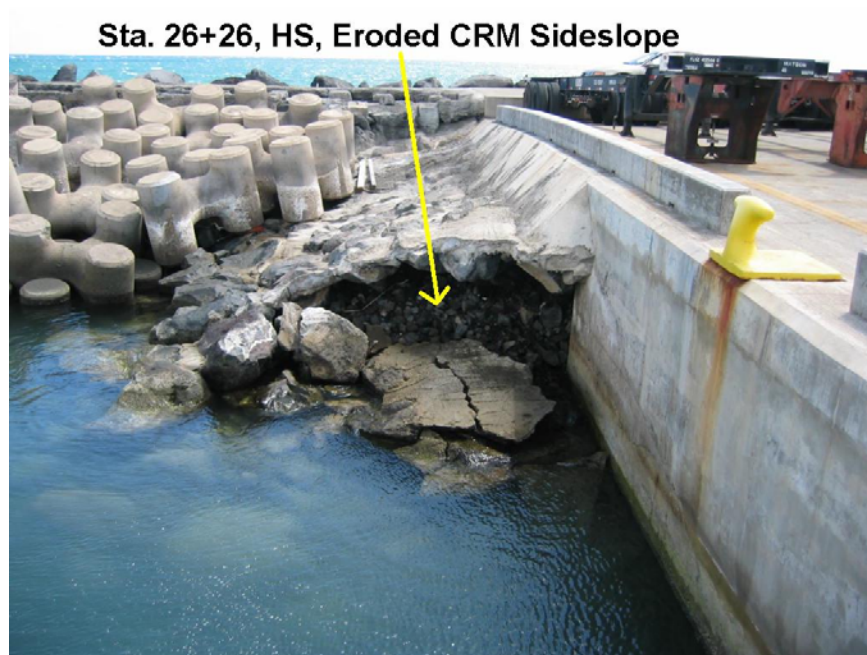
w. Sta. 26+26, HS, Eroded sideslope protection adjacent dock.
(This was brought to the Harbormaster's attention during the
out briefing).

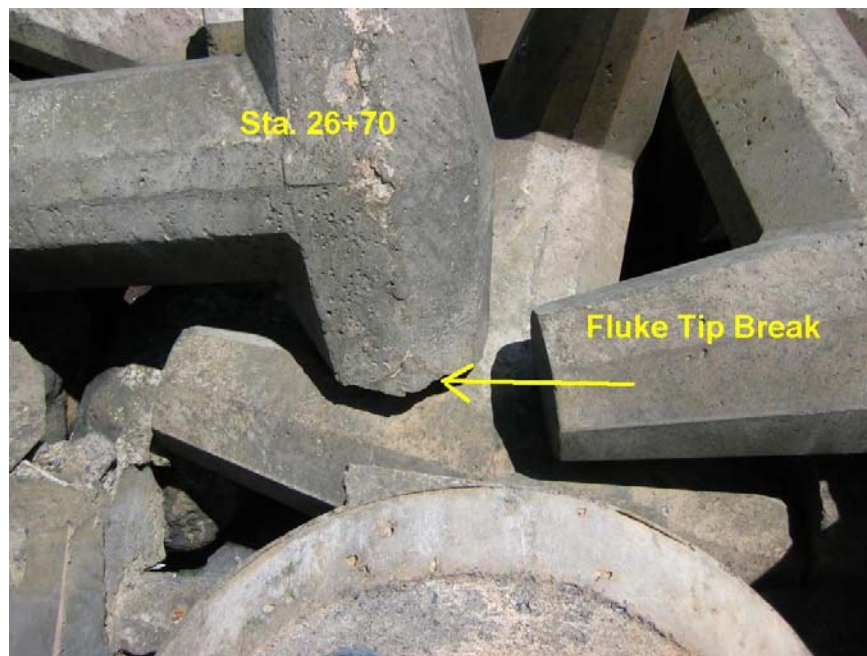
x. Sta. 26+70 (Rib 8), OS, Fluke tip break.

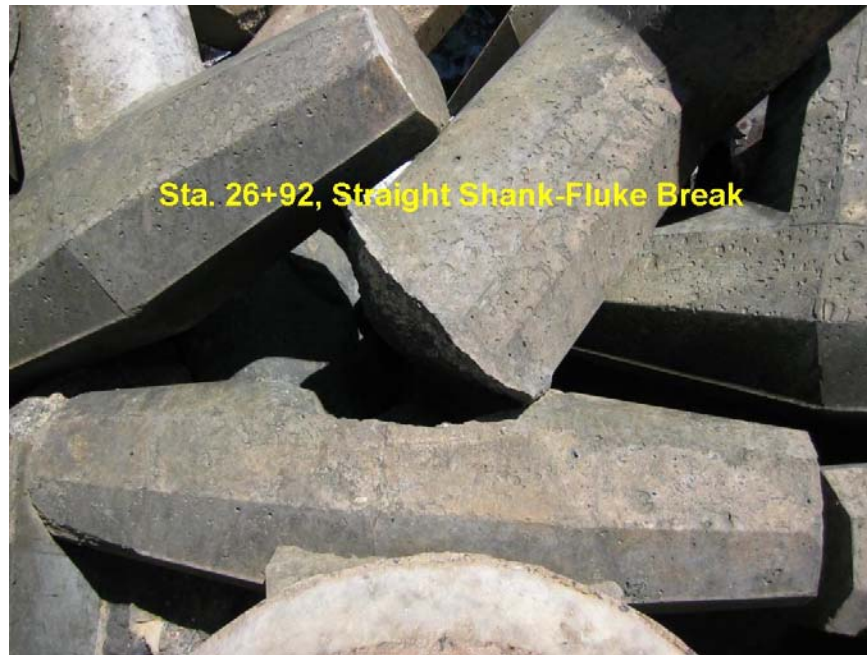
y. Sta 26+92 (Rib 12), Straight shank fluke break.

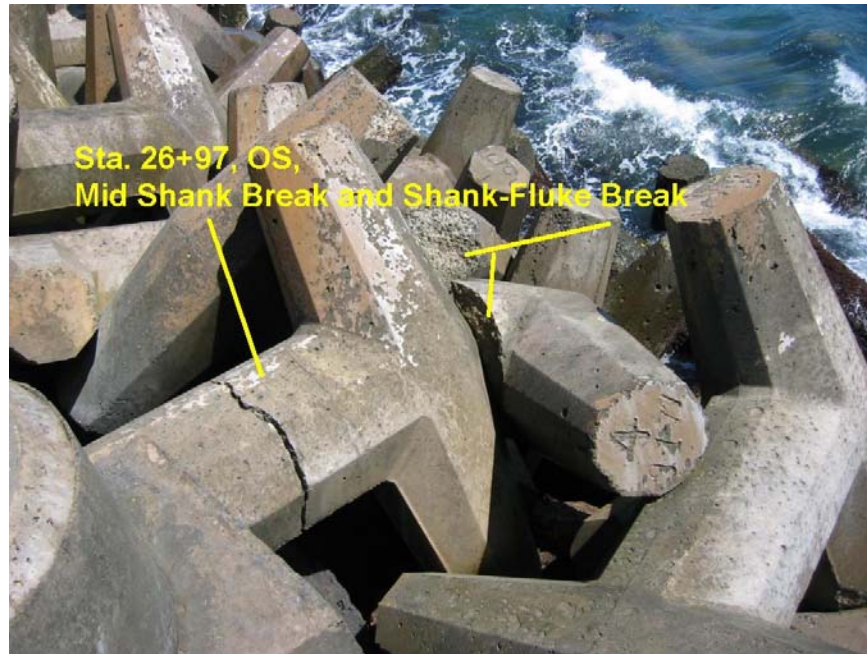
aa. Sta. 26+97 (Rib 13), Mid-shank break and shank-fluke break.

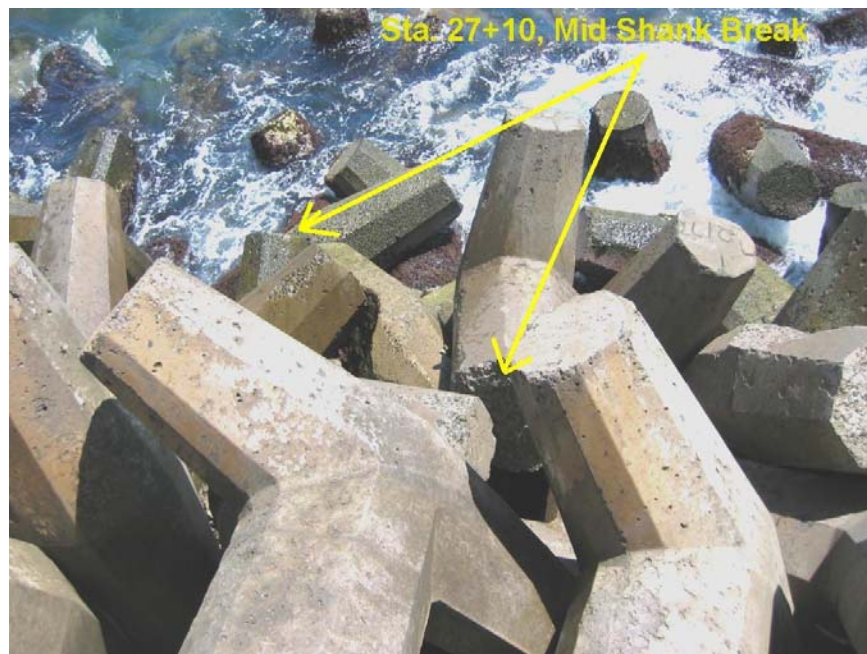
bb. Sta 27+09 (Rib 15), Shank-fluke breaks (2 ea.).

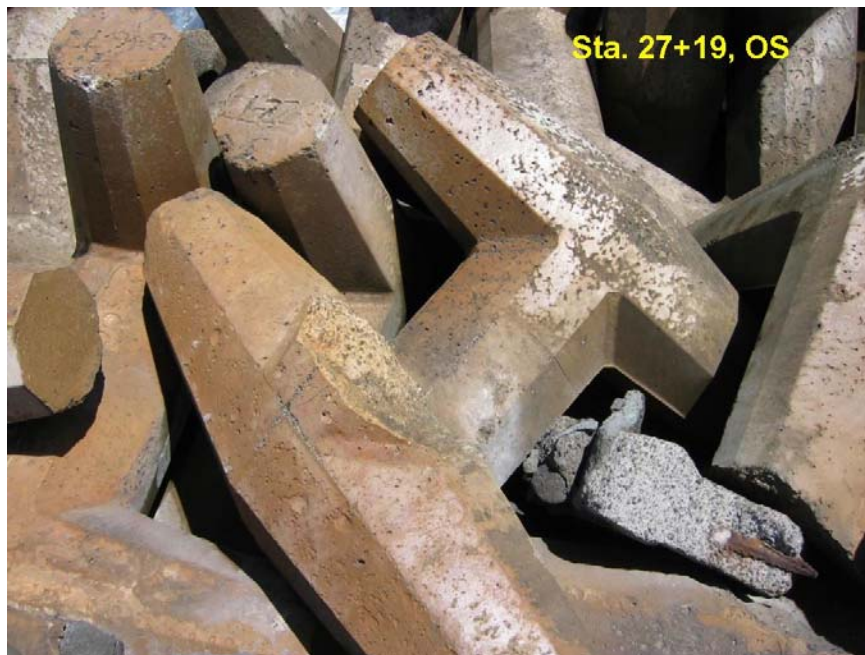
dd. Sta. 27+19 (Rib 17), OS, Straight shank fluke break.

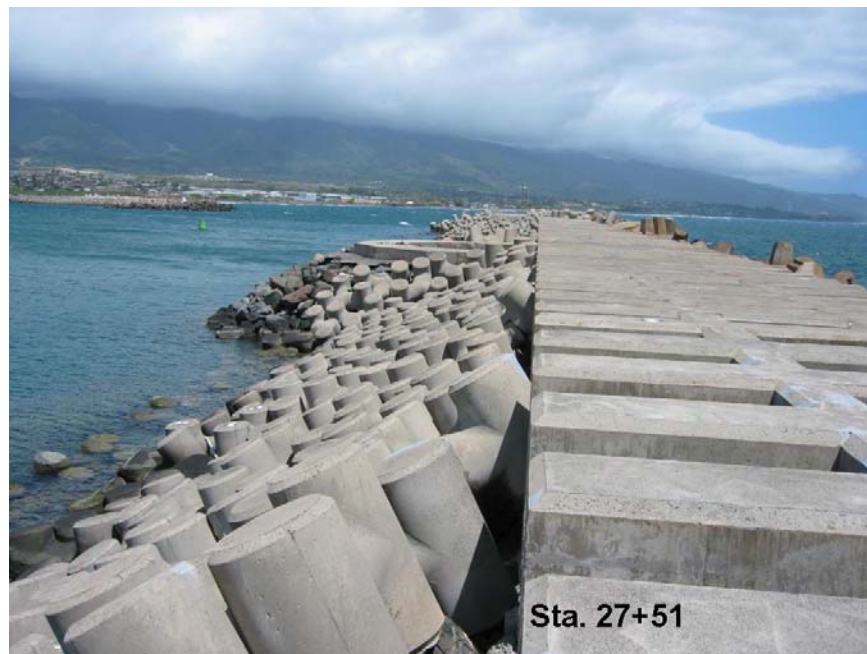
ff. Sta 27+51 (Rib 20), HS, Overview and broken tribar.

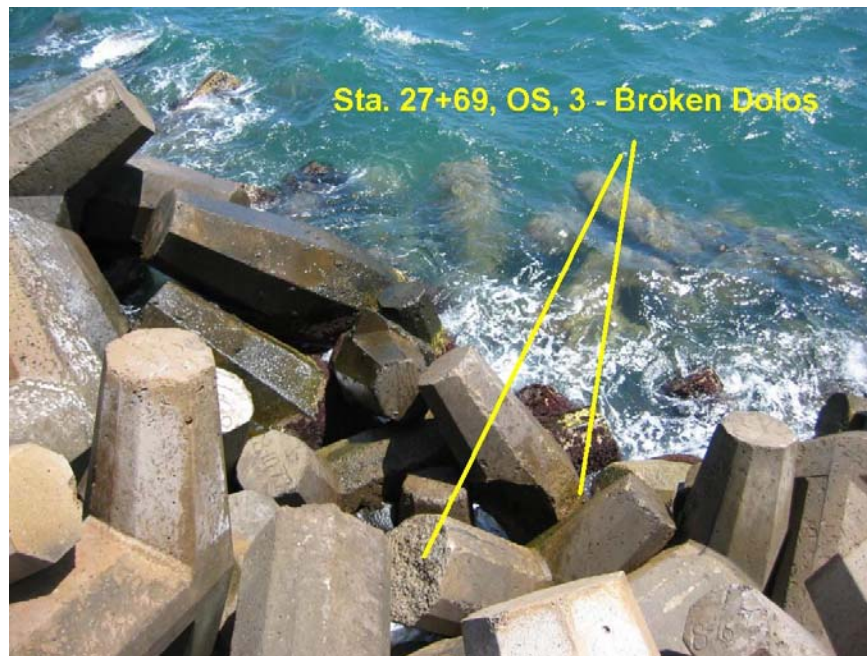
gg. Sta 27+69 (Rib 23), OS, three broken dolos.

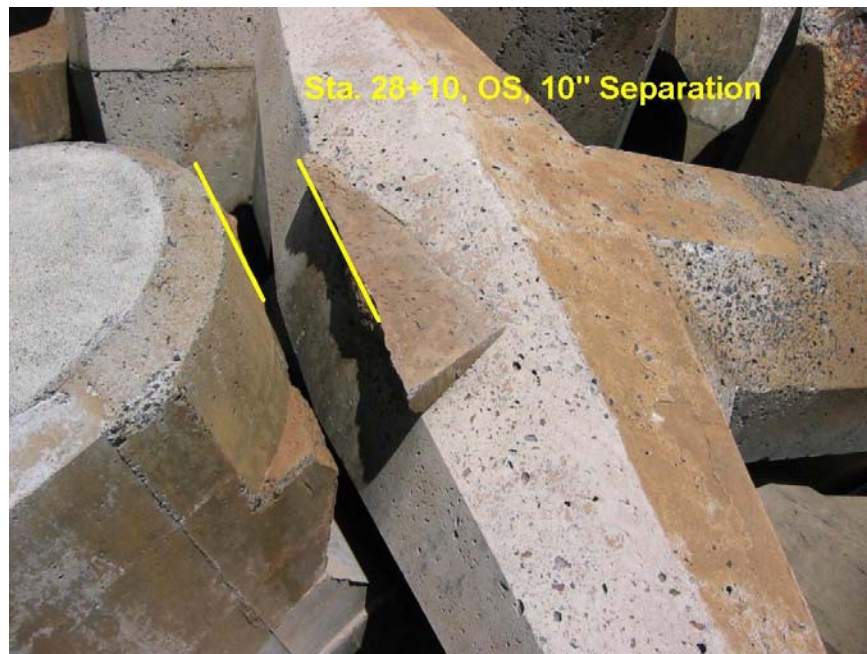
hh. Sta 28+10 (Rib 29), OS, dolo separation 10" from RC.

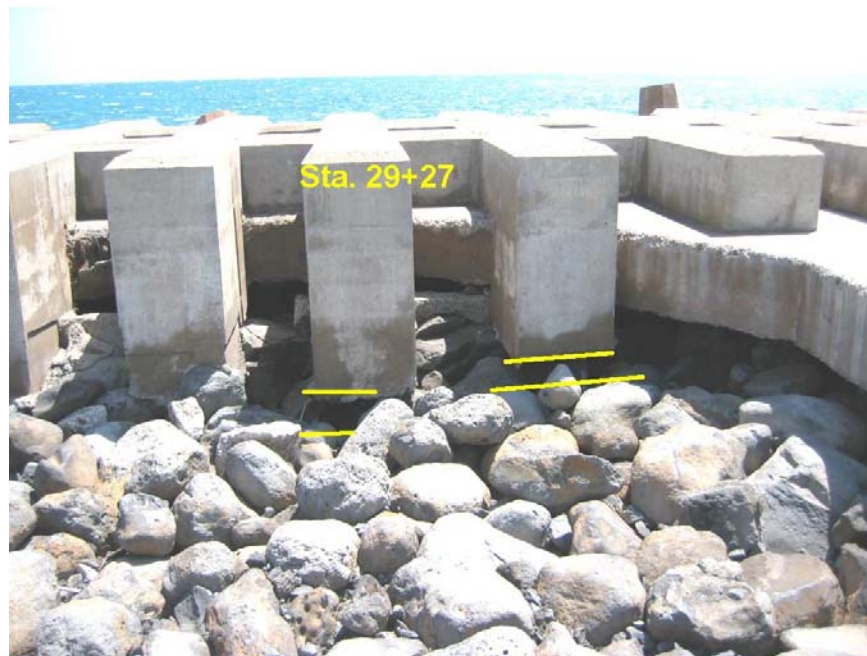
jj. Sta 29+27 (Rib 40), Centerline of first turnaround.
Settling of armor stone causing ribcap to be unsupported.

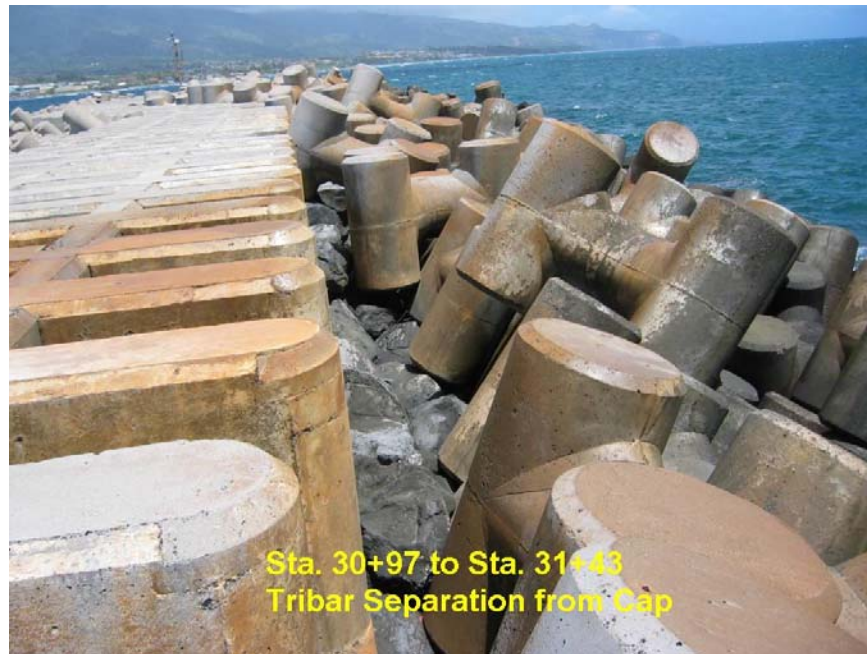
mm. Sta 30+97 (Rib 69) to Sta 31+43 (Rib 76), OS, 10 ft Tribar separation from ribcap.

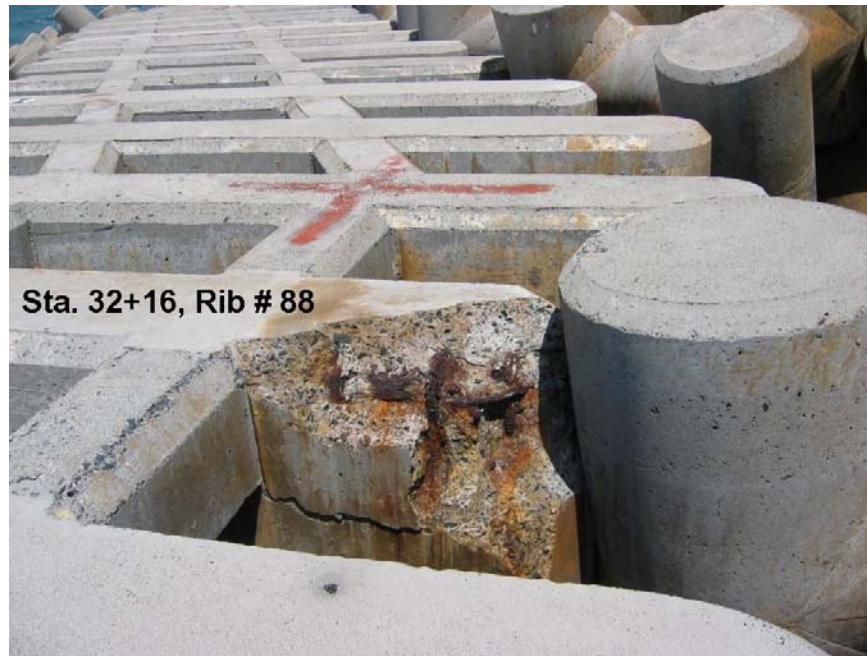
oo. Sta 32+16 (Rib 88), OS, Cracked/spalling ribcap, red cross painted.

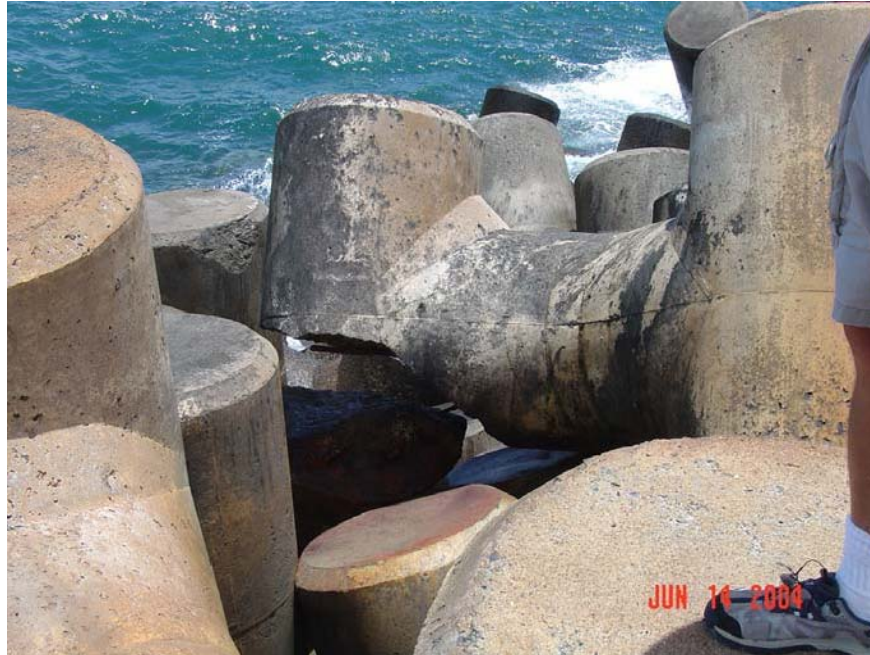
pp. Sta 32+85, Broken tribar leg.

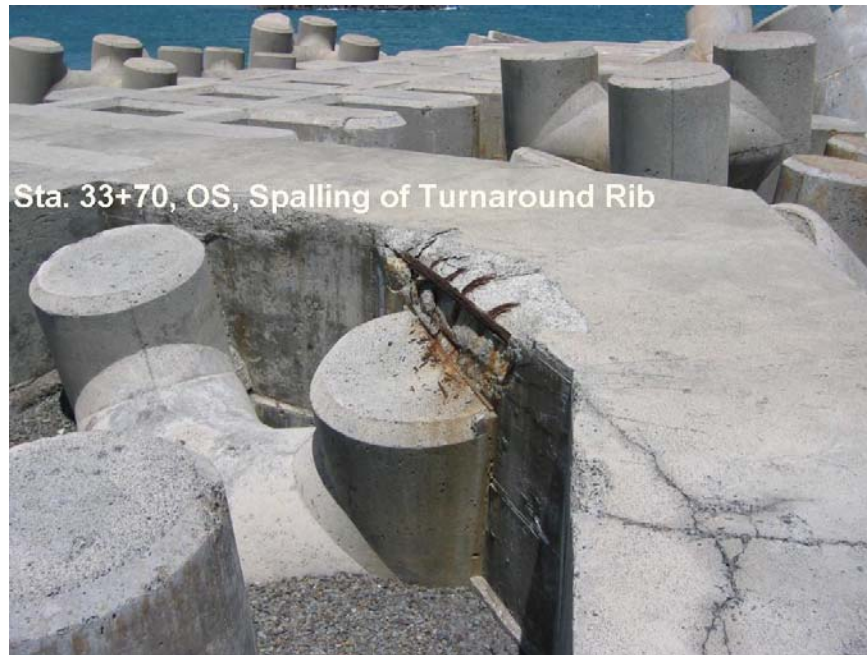
qq. Sta. 33+70, Rib cap spalling.

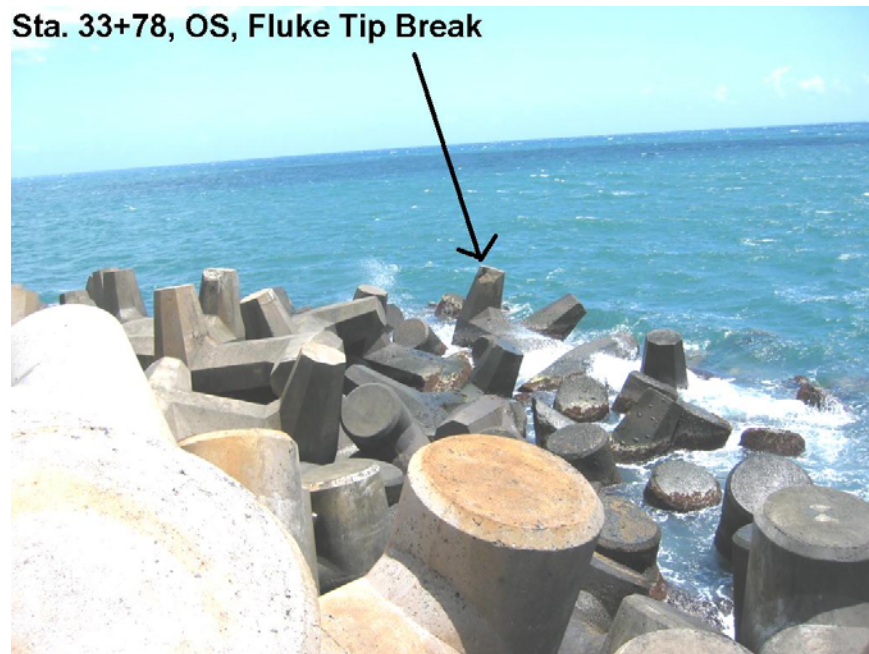
rr. Sta 33+78 (Rib 104), OS, Angle shank-fluke break.

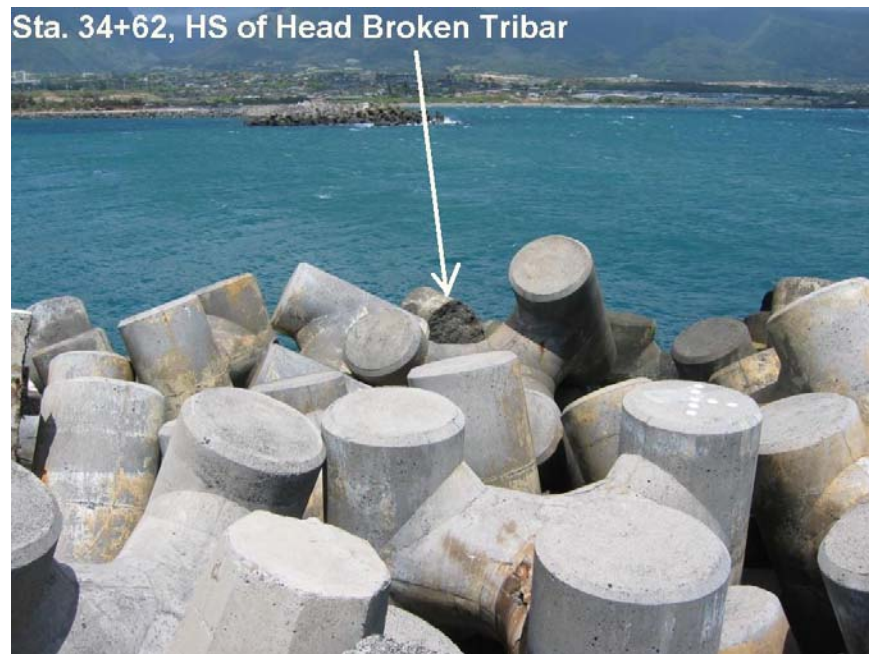
tt. Sta 34+62, HS, Broken tribar.

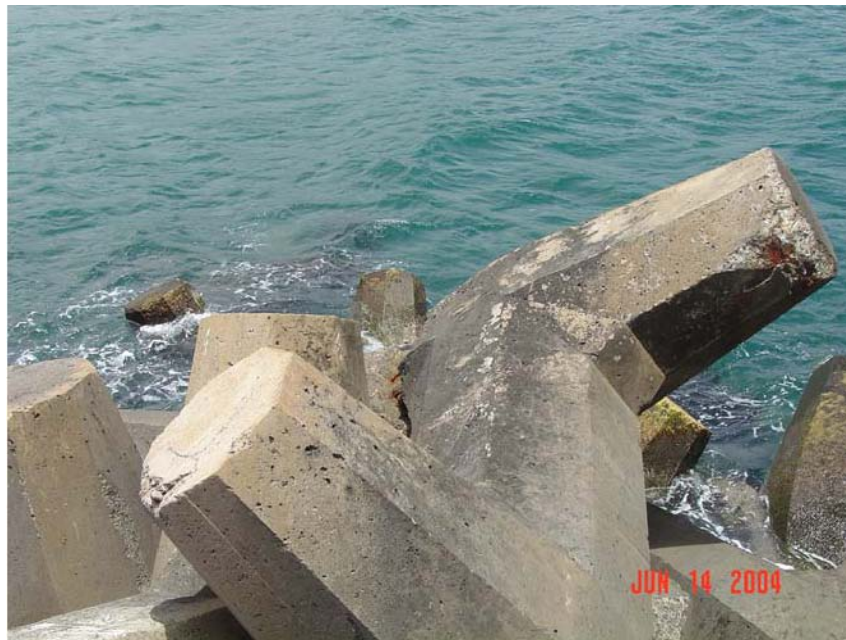
uu. Sta 35+02, Straight shank-fluke break.

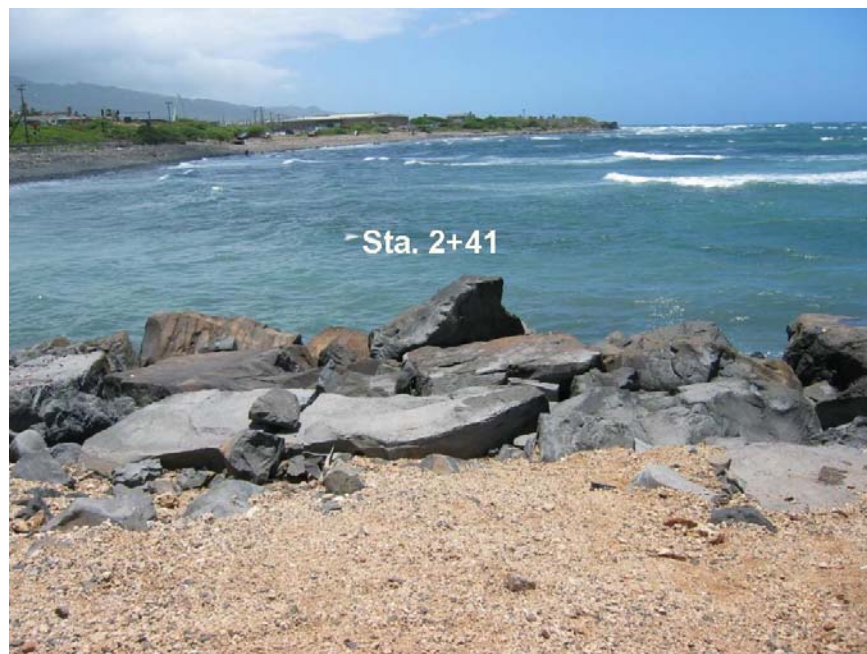
b. Sta 2+41, OS, Flipped armor stone.

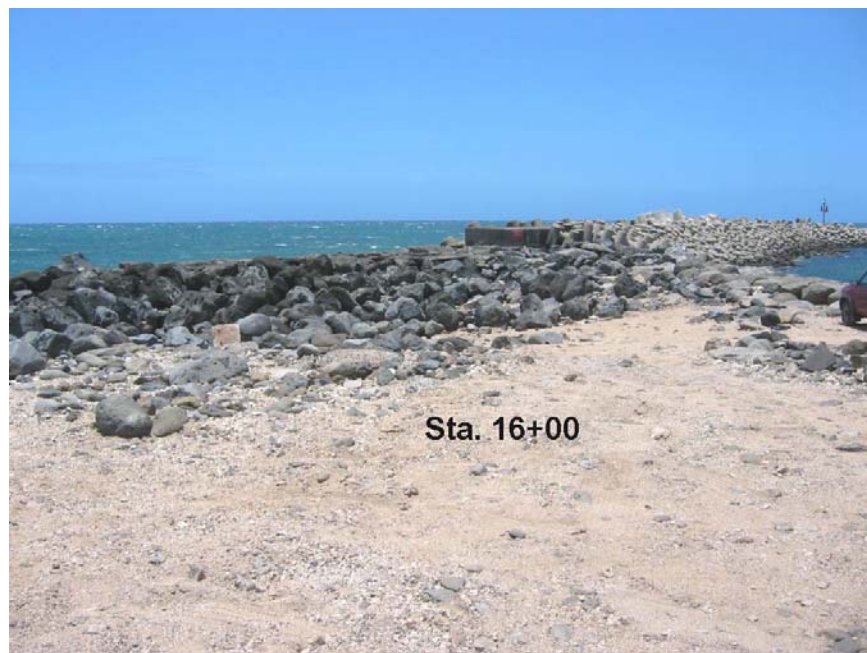
h. New scour noted at HS of structure root.

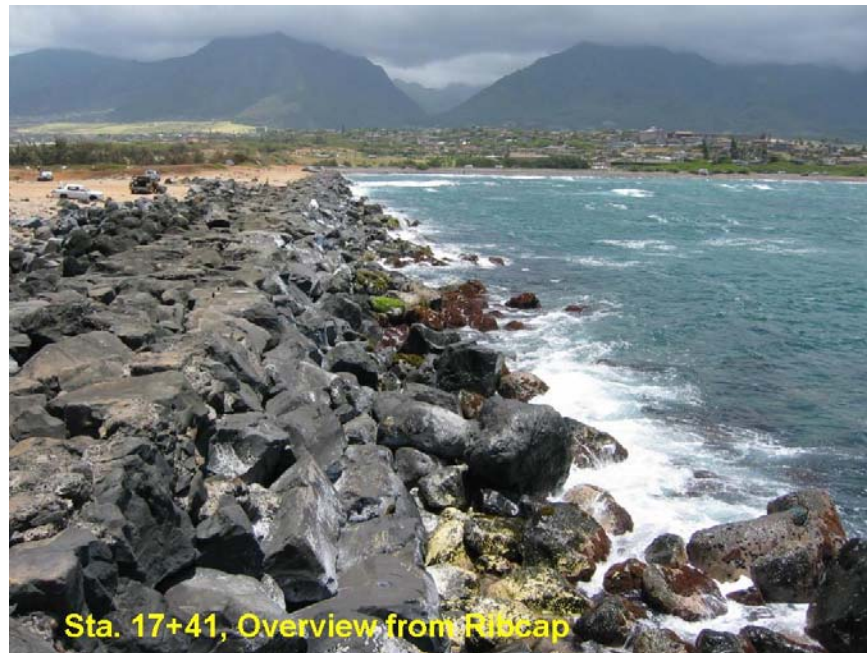
- i. Sta 17+41, OS, Sideslope steepening, monitor armor stones adjacent to toe.

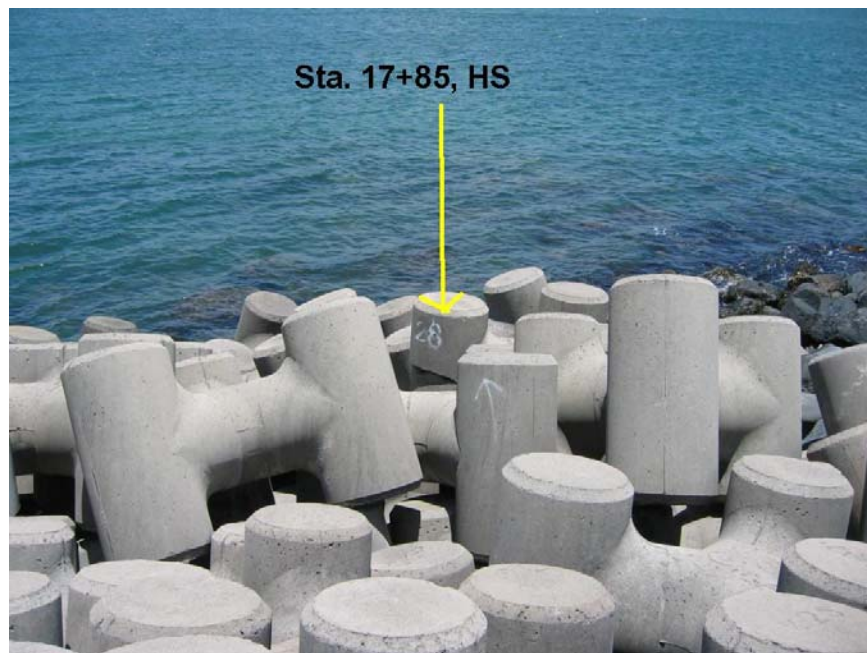
- j. Sta 17+85 (Rib 6), HS, Broken tribar.

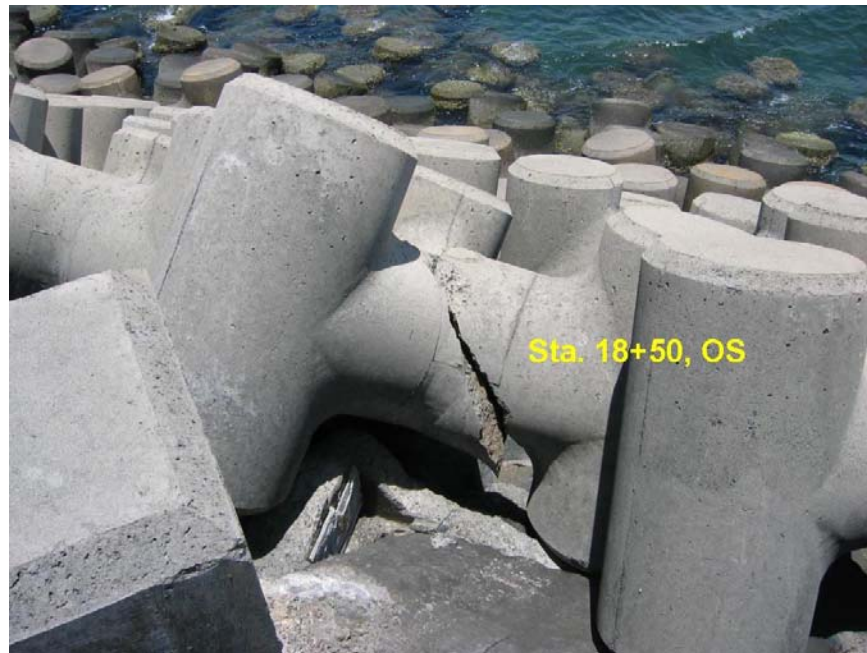
k. Sta. 18+50, HS, Broken tribar, no change this year.

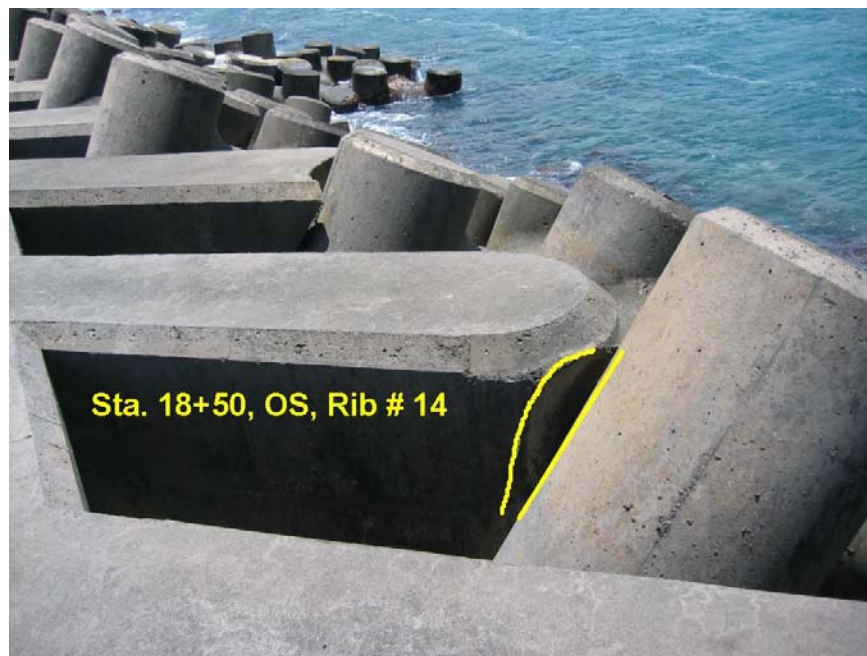
l. Sta 18+50 (Rib 14), OS, 8" separation of tribar from RC.

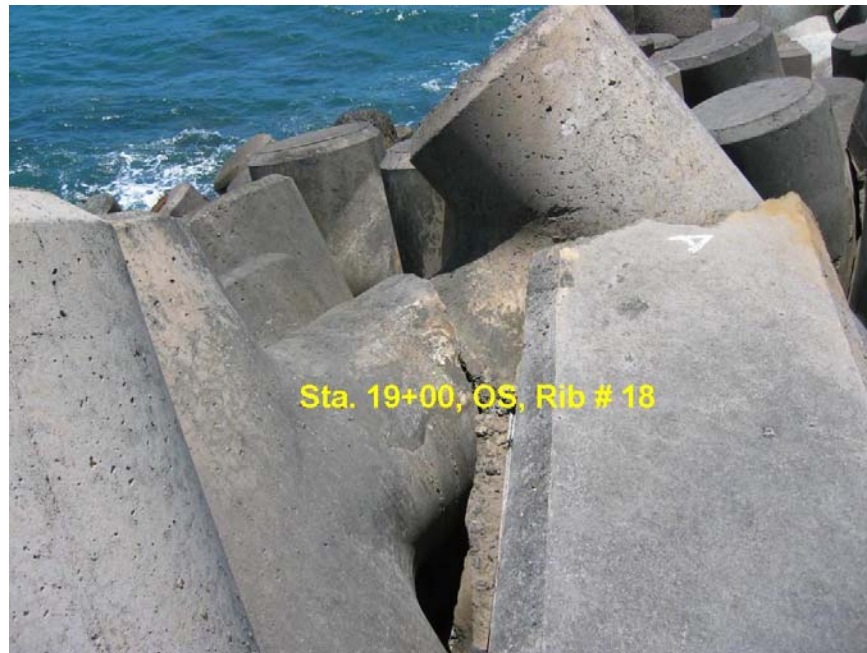
m. Sta 19+00 (Rib 18), OS, 4" separation and broken tribar.

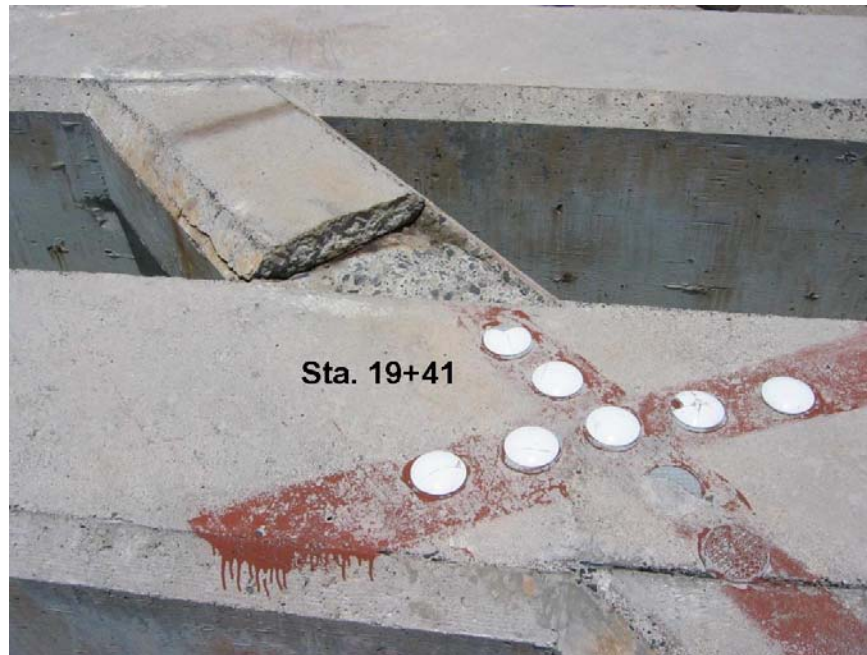
o. Sta 19+41 (Rib 30), Red cross painted and ribcap spalling.

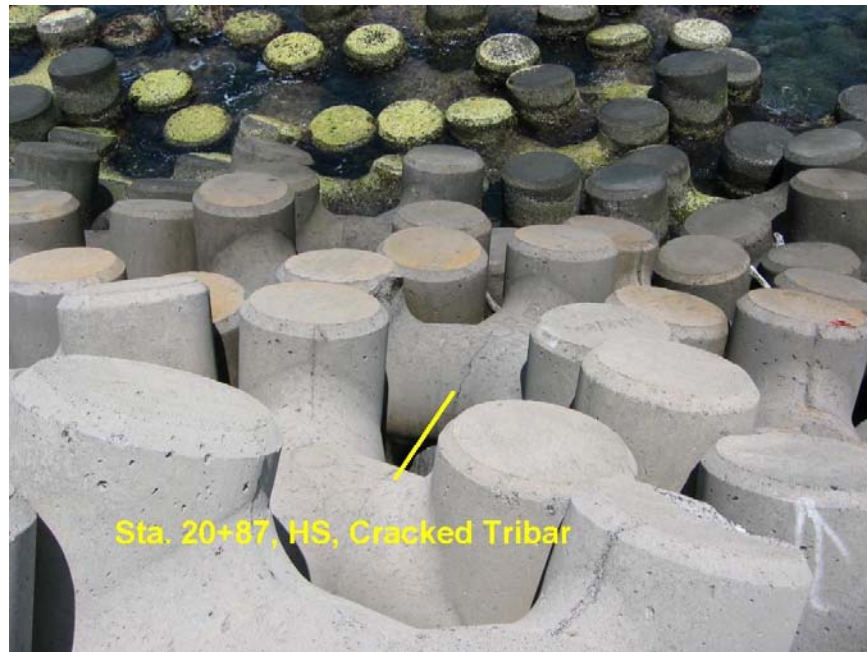
p. Sta 20+87 (Rib 40), HS, Cracked tribar.

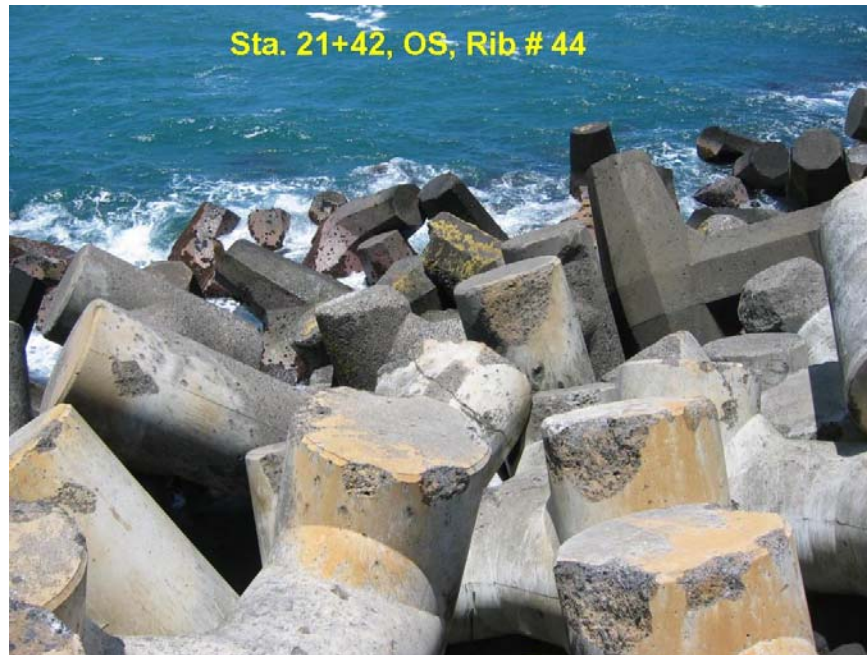
q. Sta 21+42 (Rib 44), OS, Broken tribar.

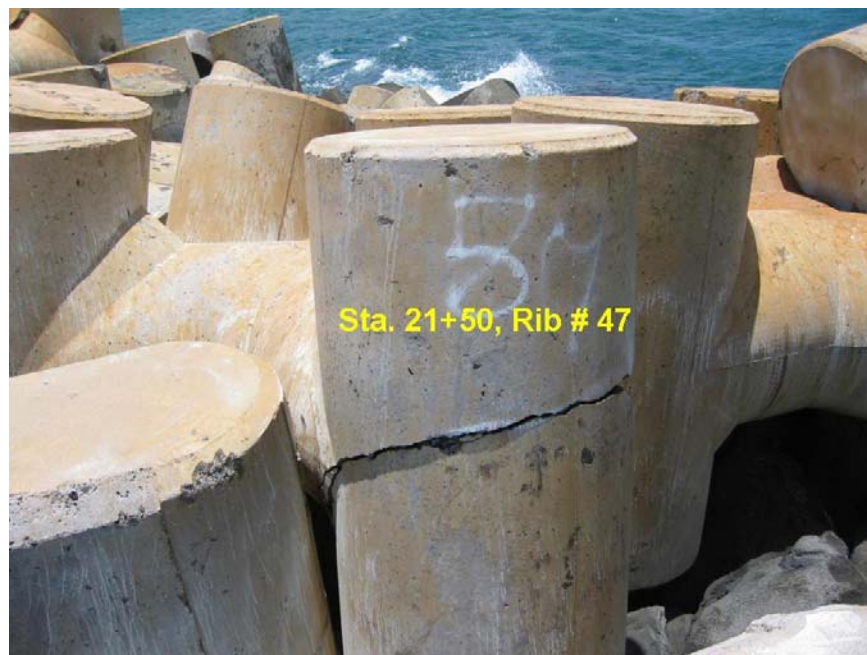
r. Sta. 21+50, OS, (Rib 47), Broken Tribar, adj ribcap.
